Inspection report

Client :	Sotech International	Tel:	+334 83454732	Fax:	--
Attn:	Mr. Alain	Supplier:			
Inspection Date:	2022-05-09	<input type="checkbox"/> 1 st / 2 nd Re-inspection (Previous Report No.)			
Product Description:	Vacuum Cleaner				
Manufacturer Name:					
Manufacturer Location:					
Manufacturer Contact:					
Service Required:	<input checked="" type="checkbox"/> FRI (Final Random Inspection)	<input type="checkbox"/> DPI (During Production Inspection)	<input type="checkbox"/>

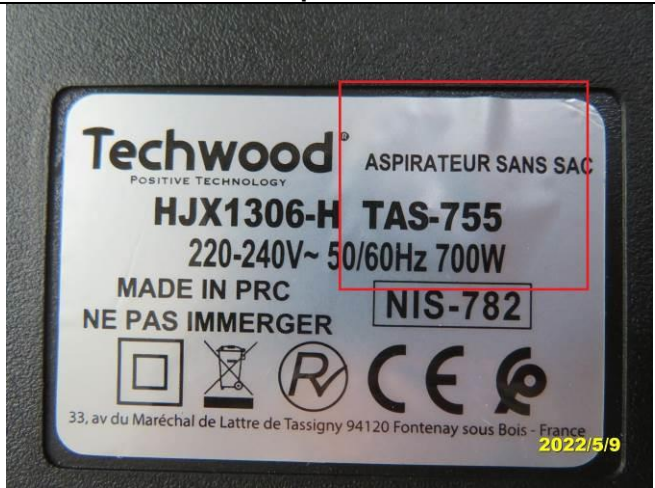
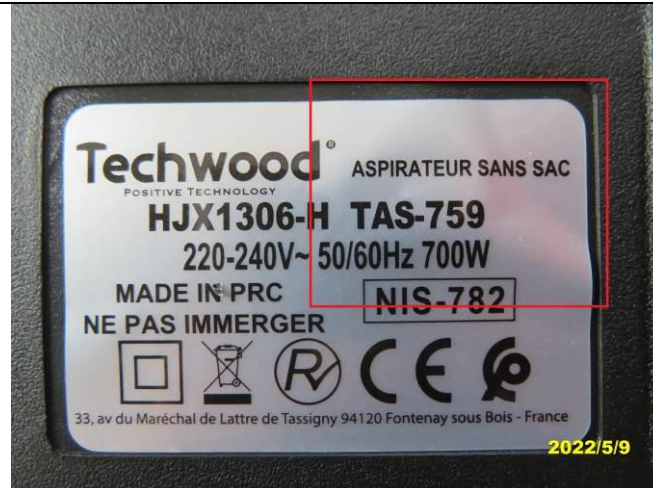
A-2: Remarks and Comments								
	Please confirm							Status
1	For all inspected samples, rating label was not smooth. Because there was an injection port under the rating label. Factory reworked rating label and provided guarantee letter, then accepted by client .							Information
2	Production code on gift box and rating label was 'NIS-782', but 'IYA-782' was required by the PO. Accepted by client.							Information
3	Spare part:							Information
	PO no.	Gift box	Two parts Tube	Floor / carpet brush	2 in 1 nozzle	Flexible hose	Washable sponge filter	HEPA filter
	2022024	15pcs	10pcs	5pcs	10pcs	5pcs	30pcs	20pcs
	2022025	15pcs	10pcs	5pcs	10pcs	5pcs	30pcs	20pcs
	01022022	15pcs / item	10pcs / item	5pcs / item	10pcs / item	5pcs / item	30pcs / item	20pcs / item
4	No PO no. on the package and rating label.							Information
5	LVD and CDF were provided by the factory.							Information
6	Production code: 'NIS-782' on gift box and rating label.							Information

1. Remark 1: Rating label was not smooth	2. Remark 1: Rating label was not smooth

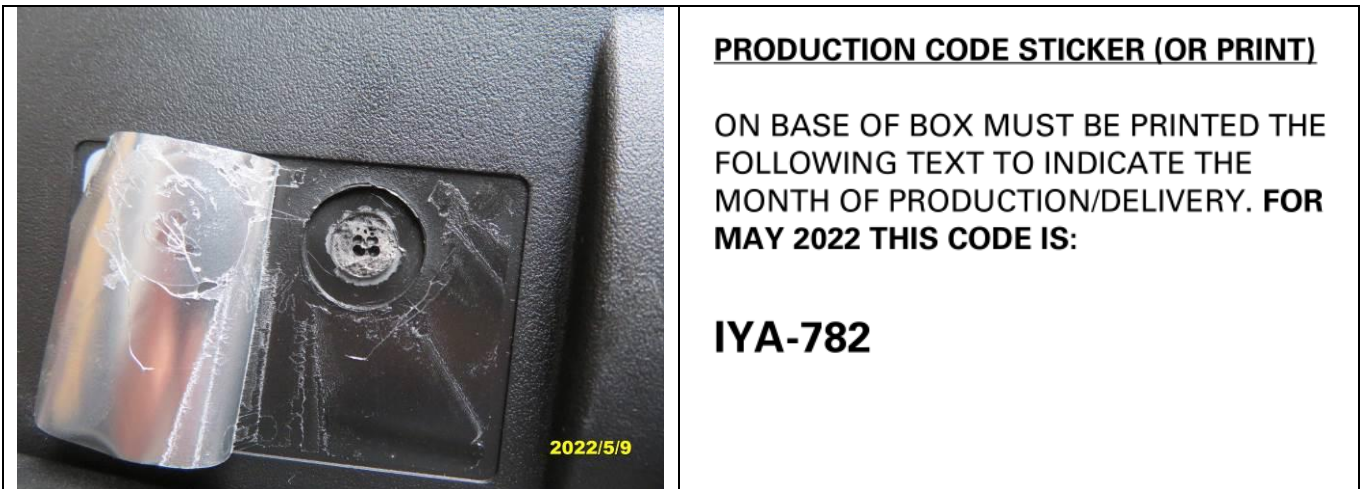
PRODUCTION CODE STICKER (OR PRINT)

ON BASE OF BOX MUST BE PRINTED THE FOLLOWING TEXT TO INDICATE THE MONTH OF PRODUCTION/DELIVERY. **FOR MAY 2022 THIS CODE IS:**

IYA-782

3. Remark 1: Injection port under the rating label

4. Remark 2: Production code 'IYA-782' on PO

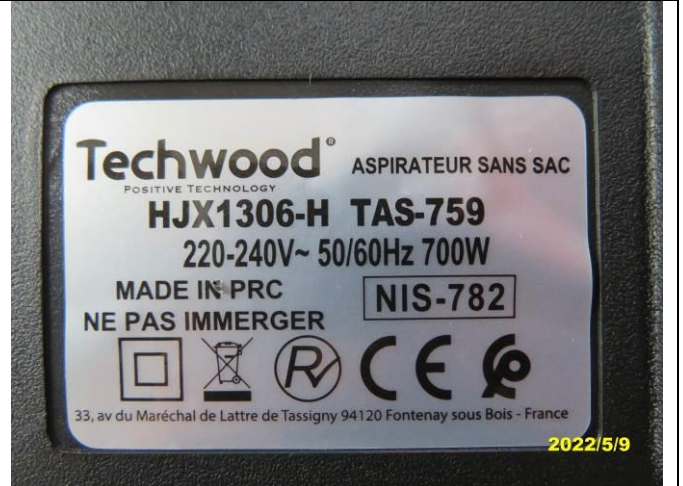
5. Remark 2: Production code 'NIS-782' on RL

6. Remark 2: Production code 'NIS-782' on RL

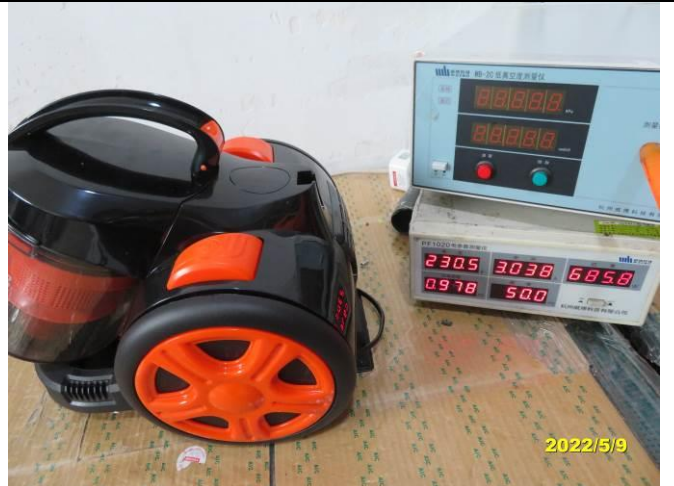
Test performed	Sample size	Result	Comments
Hi-pot test (Fixed)	80pcs	Pass	3,300 V, 2 s, 5mA, no breakdown.
Basic function test (Fixed)	80pcs	Pass	230 V~, 50 Hz, switch on/off
Smell check (Fixed)	80pcs	Pass	No abnormal smell
Full function check (S-3)	20pcs	Pass	230 V~, 50 Hz, operation as normal use.
Input power consumption check (S-3)	20pcs	Pass	230 V~, 50 Hz: 651-694W
Vacuum capacity check (S-3)	20pcs	Pass	230 V~, 50 Hz: 19.4-21.1Kpa
Internal check (S-1)	5pcs	Pass	No damage, pressure mark, rust, crack
Suction power check (S-1)	5pcs	Pass	131.7-143.6W
Air flow check (S-1)	5pcs	Pass	1.22-1.29m ³ /min
Noise check (S-1)	5pcs	Pass	67.1-70.3dB
Application check	2pcs	Pass	230 V~, 50 Hz
Endurance test (S-1)	5pcs	Pass	230 V~, 50 Hz
Power cord length measurement	2pcs	Pass	400-402cm (without plug)
Rub test	2pcs	Pass	Cloth with water and hexane, rub for 15s.
3M tape check	2pcs	Pass	3M type 810 tape check, no printing peel off

114. Power consumption test

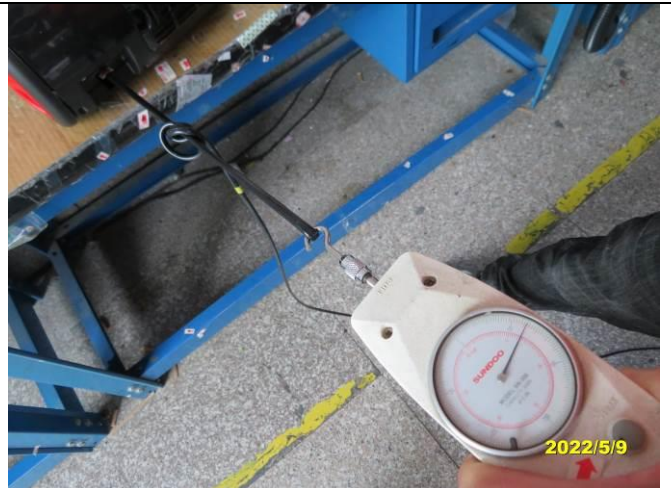
Strain relief test	2pcs	Pass	60 N, 25 times, displacement less than 2 mm
Stability check	2pcs	Pass	No overturn at 10° slope.

120. Strain relief test

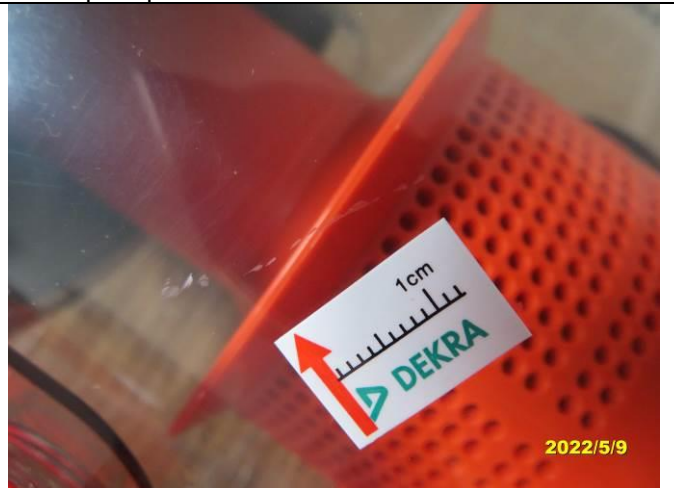
A-1) : AQL and Defects Finding					
Inspection Sampling Standard Adopted: <input checked="" type="checkbox"/> ISO 2859-1			Nonconformity (defective)		
Inspection Plan:	Single sampling plans for normal Inspection		Critical	Major	Minor
Inspection Level:	Fixed	AQL:	Not Allowed	2.5	4.0
Inspection with:	<input type="checkbox"/> approved sample	Sample Size:	80	80	80
<input type="checkbox"/> specific check list	<input checked="" type="checkbox"/> general check list				
Defect Description					
Dirty mark on surface TAS-759					1
Scratch mark on surface TAS-759					1
Scratch mark on surface TAS-755					2
Total Found:			0	0	4
Max. Allowed:			0	5	7

126. Scratch mark on surface-minor TAS-759

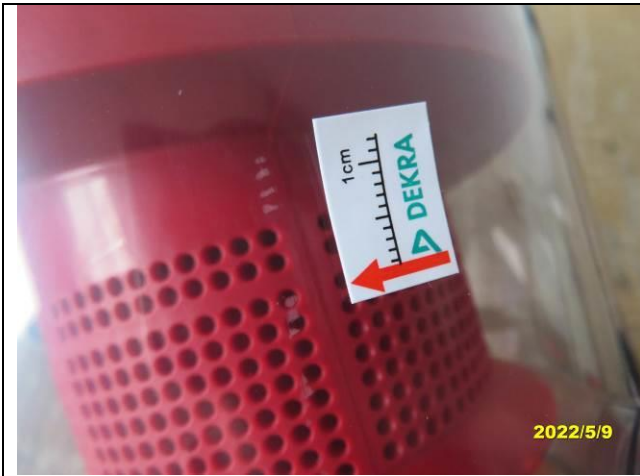
127.Scratch mark on surface-minor TAS-755
